# Shingles Featuring Scotchgard™ Protector

# Scotchgard™ Protector

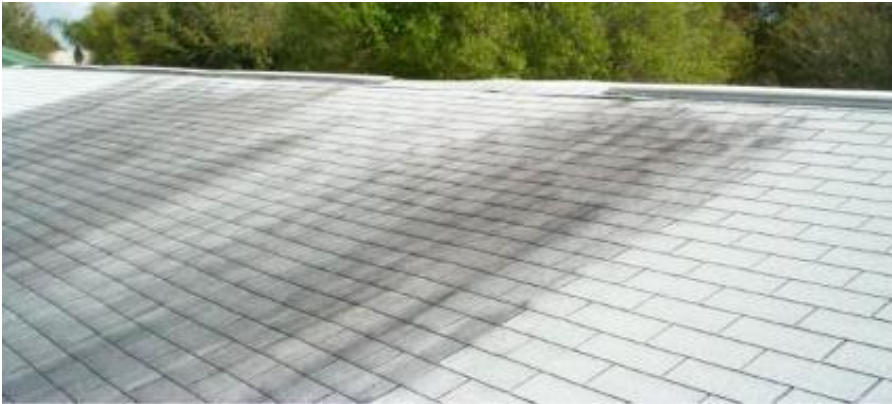
A 5-year-old roof in Florida. The extent of black streaks caused by algae may vary based on climatic conditions.

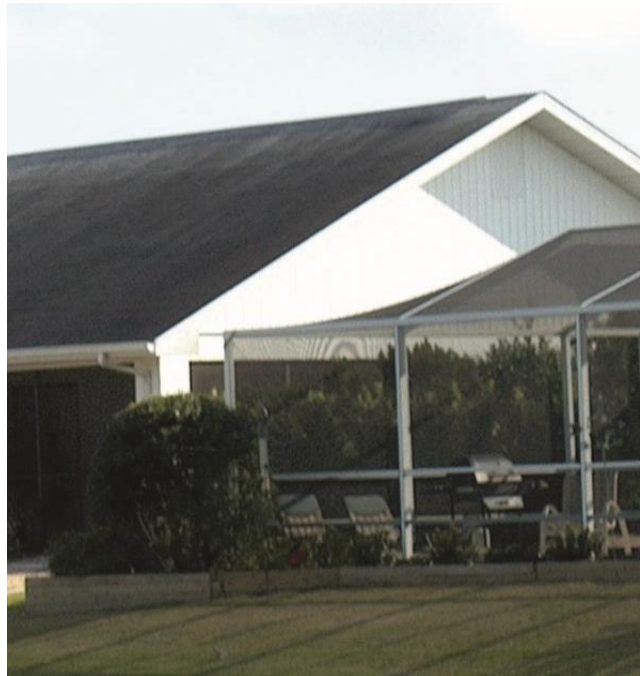
6-year-old north facing roof in Florida with no copper present

Lower blend percent can result in faster development

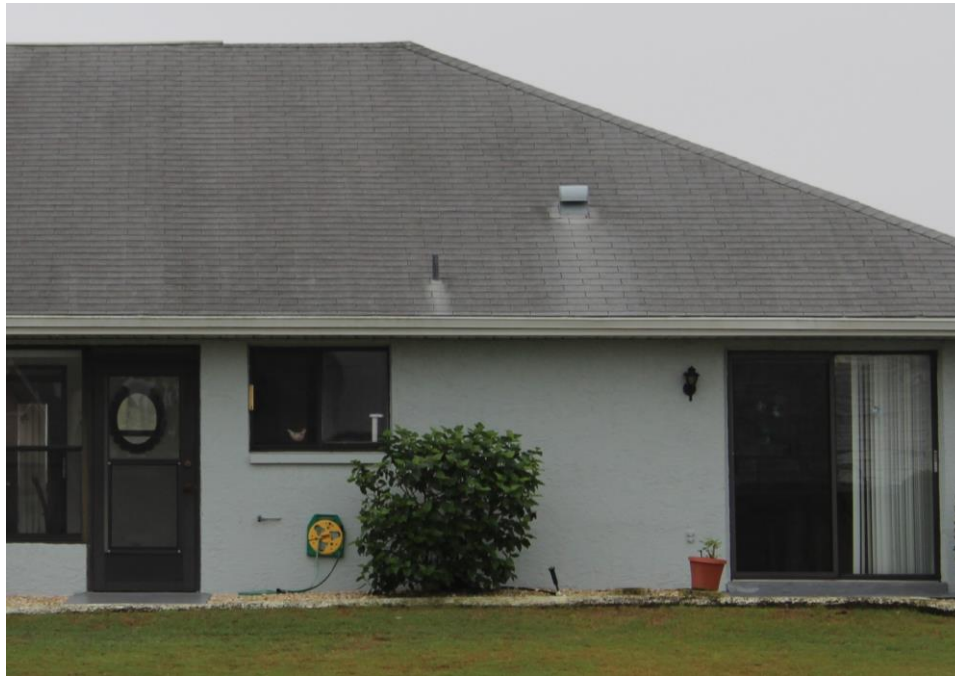
8-year-old north facing roof in Florida with 6% copper present

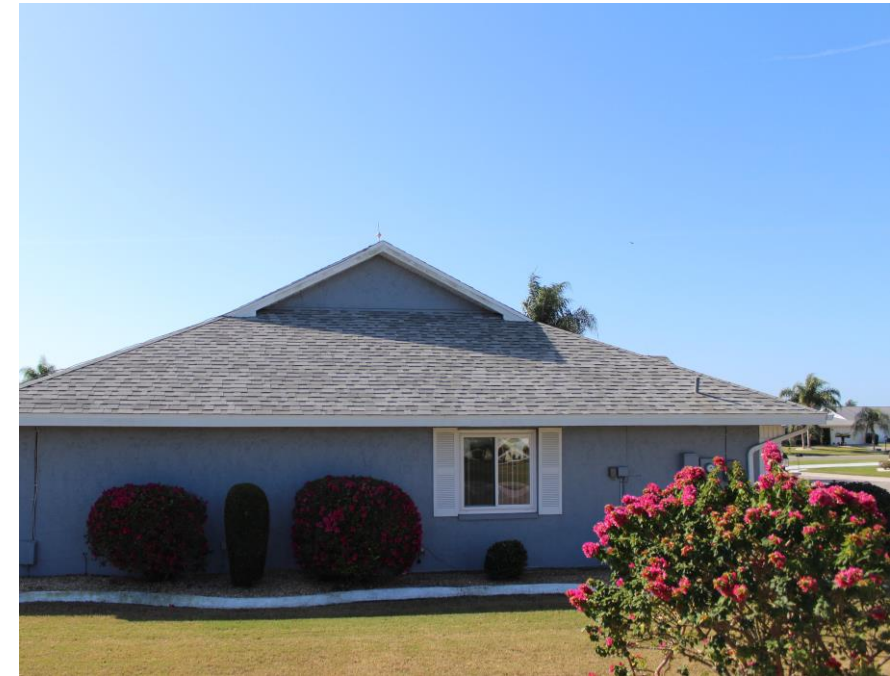
9-year-old north facing roof in Florida with 10% blend of copper

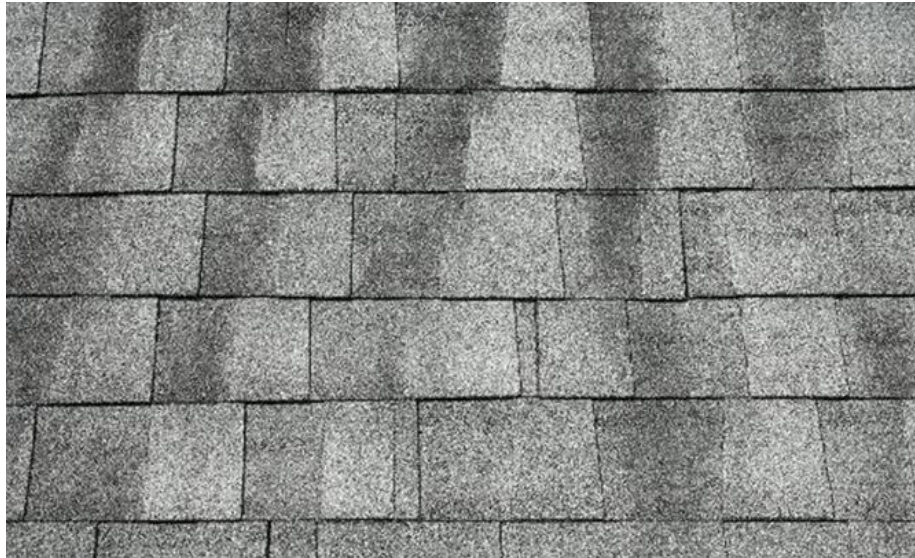
A 10-year-old roof in Florida. An example of shingles where copper is only present in the tooth of the shingle.

The Scotchgard™ Protector system requires copper-containing granules in all the shingles, including the hip and ridge. The uniform distribution helps prevent any gaps where black streaks caused by algae can get established.

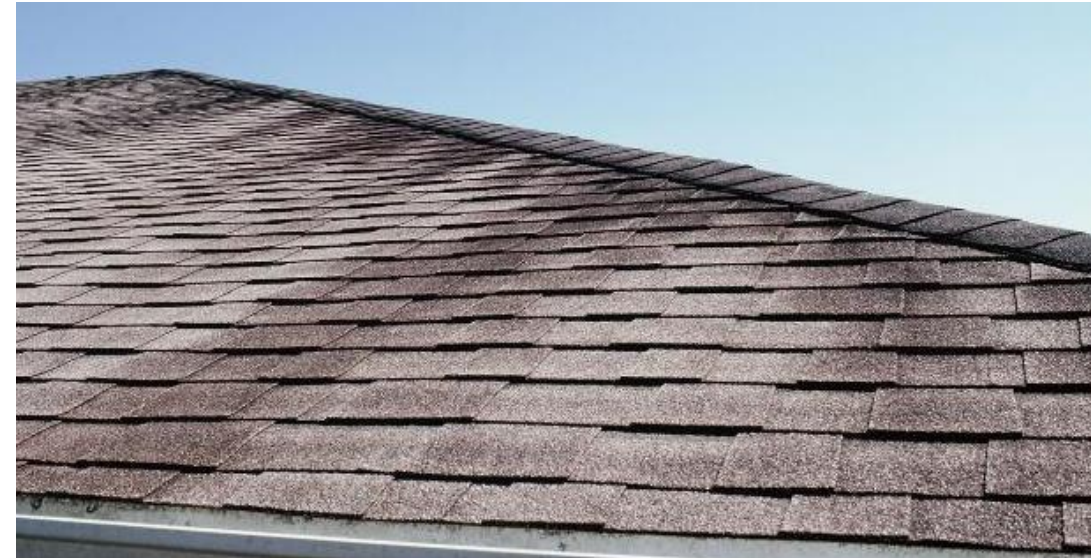
An 8-year-old roof in Florida. An example of a roof where copper is not present in all the shingles.

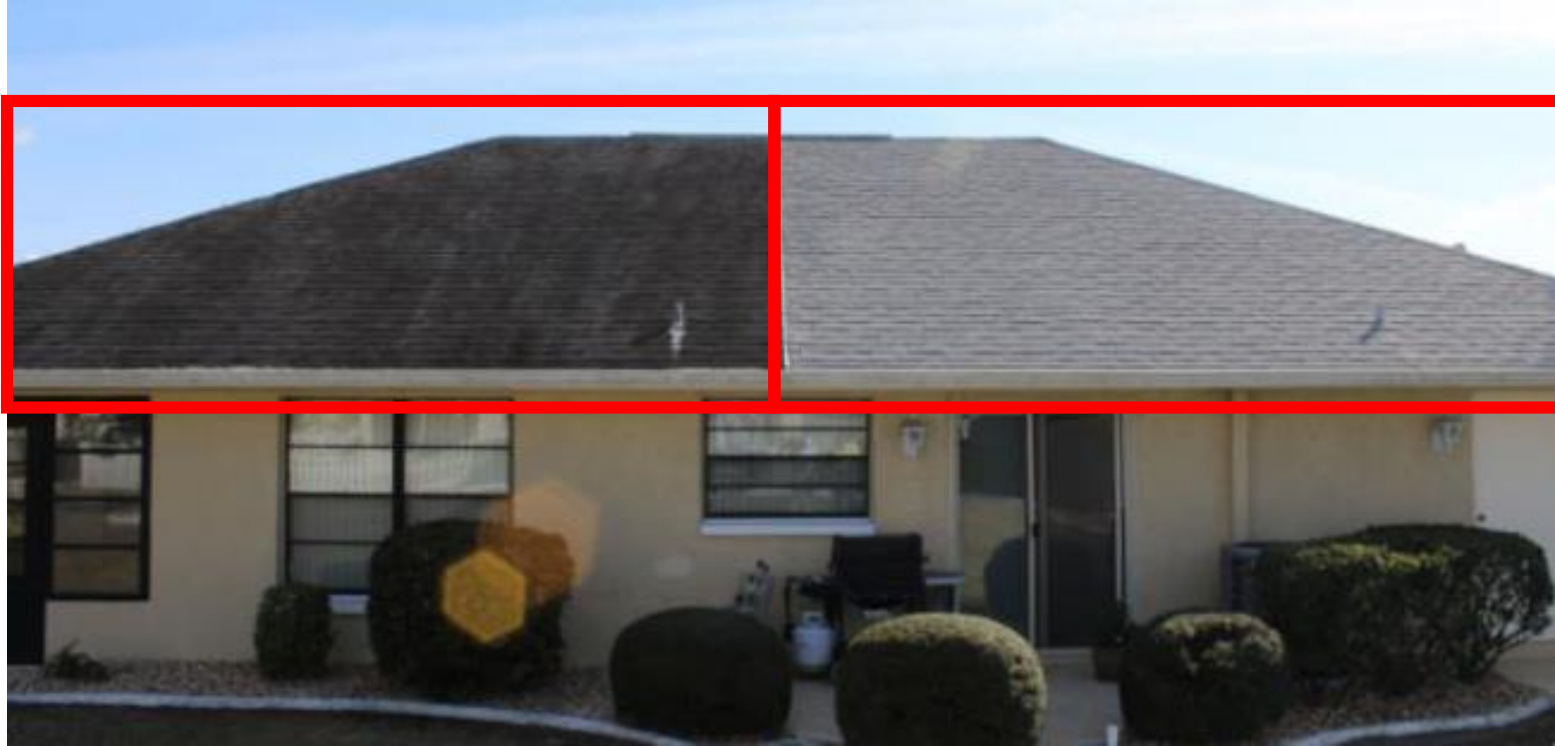
A roof in Florida.  
Shingles with 0% (left) and a minimum 10% (right) blend copper-containing granules after six years. Results may vary based on climatic conditions.
